THE OLD PARSONAGE

AN ANALYSIS OF THE ARCHITECTURAL AND HISTORIC SIGNIFICANCE

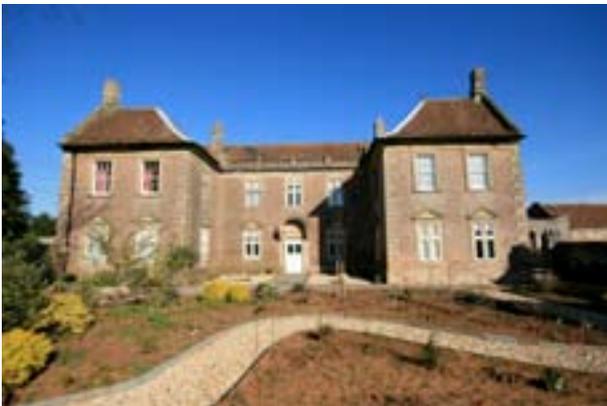
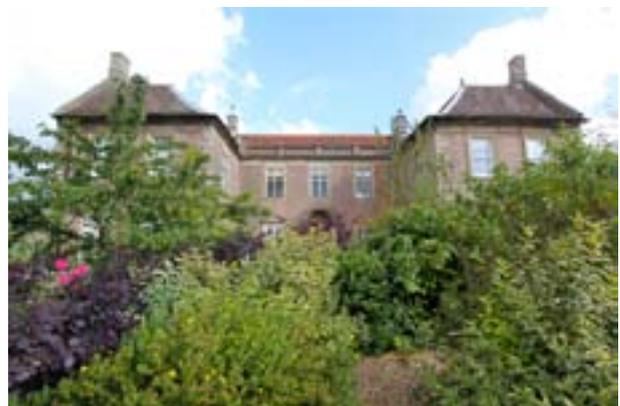
The country Baroque elevations of the Old Parsonage of the front Wells Road elevation

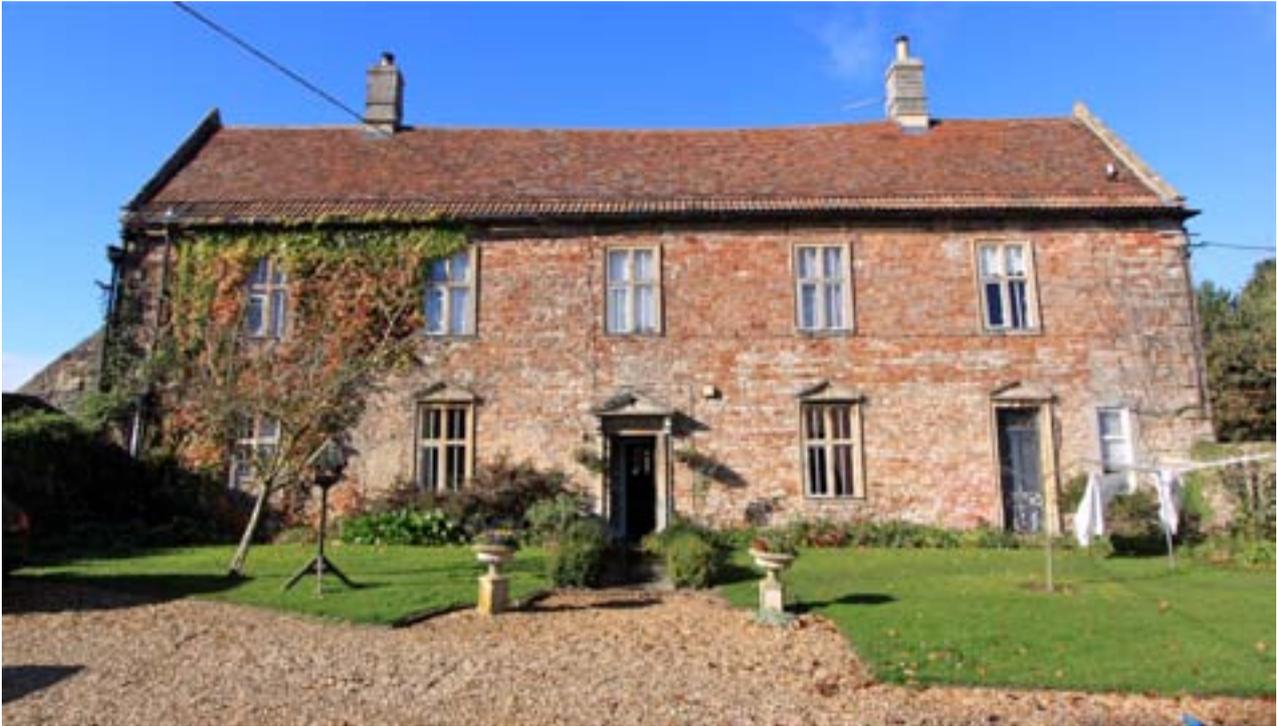
The original front elevation of the property now part of the rear courtyard

It is possible to detect an earlier build, which predates the early C18th Baroque phase, within the main body of this facade. The lower ground floor level of the elevation is constructed of white Lias rubble stone, laid to course, which has been extended upward in a contrasting red sandstone to form an additional first floor level, in a rugged uncoursed manner. This suggests that the building was originally single storey in construction which has been built up and laterally extended by a single bay to both the North and the South.

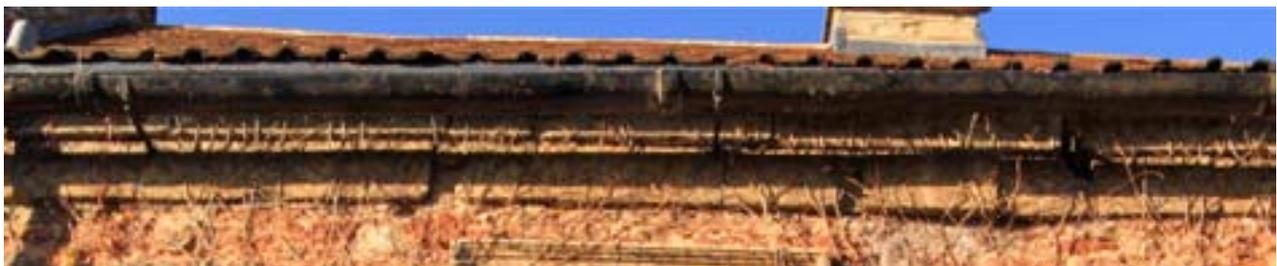
Whilst the natural colouring is pleasing to the eye the elevation was originally designed to be rendered over to protect the stone against the weather, a small area of which survives to the left of the entry.

As part of the Baroque phase of early C18th building the facade was built up and extended, punctuated by a single door entry and a series of stylistic conceived Bath stone cross transom mullion windows, incorporating pediment detailing over at ground floor level, in a symmetrical fashion all surmounted by a profile cove cornice detail matching that found on the front elevation to the Wells Road.

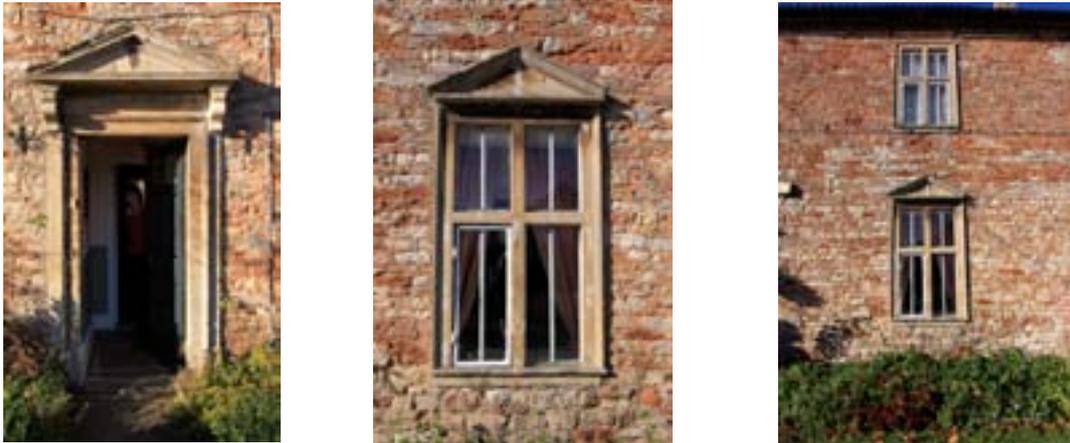
This long lateral elevation punctuated by these regularly spaced and symmetrically balanced door and window openings, incorporating cyma moulded classically styled architraves and surrounds, portrays an architecturally mannered piece of some distinction and advancement.

The classical detailing of the door and window openings within the facade

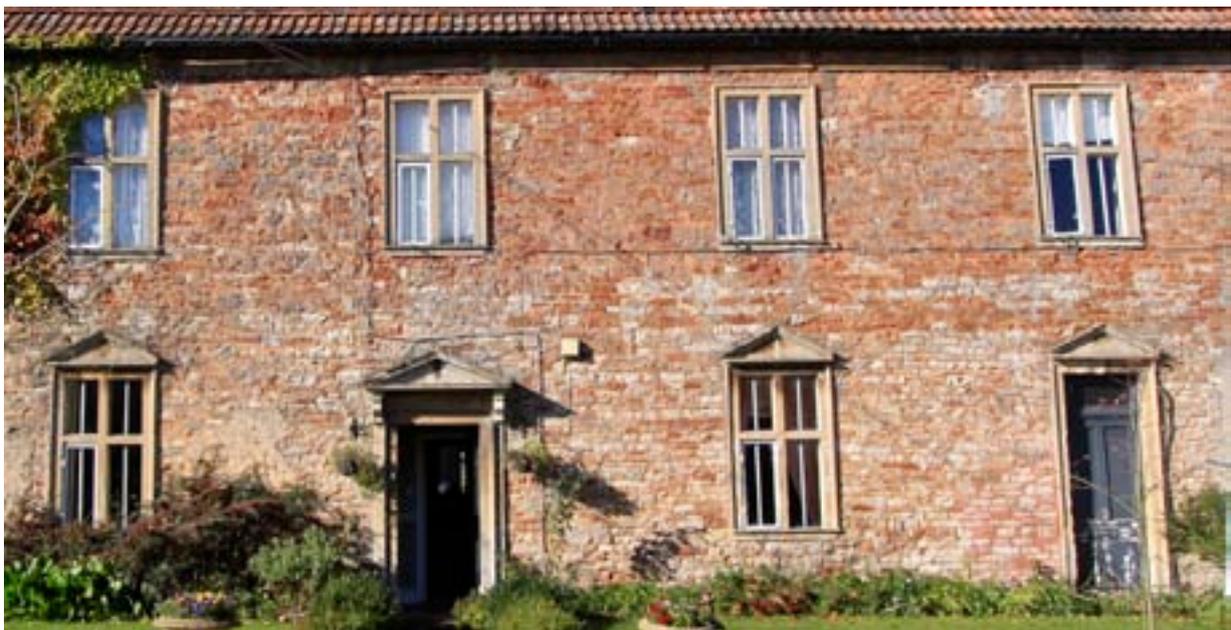
Detailing of the stonework illustrating the build up and classical remodelling of the elevation

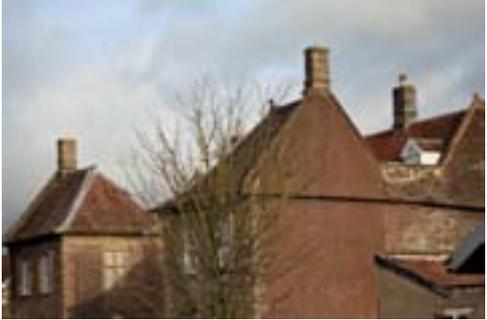
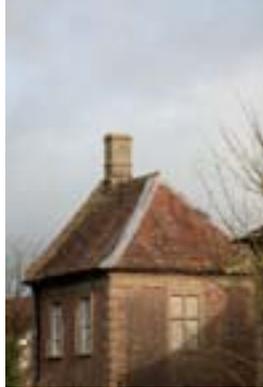
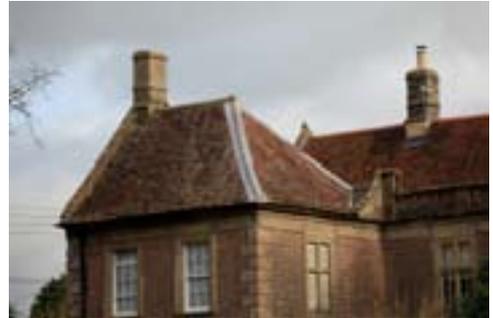
The unfolding of the roofscape panorama on the approach from Wells heightens the sense of architectural anticipation

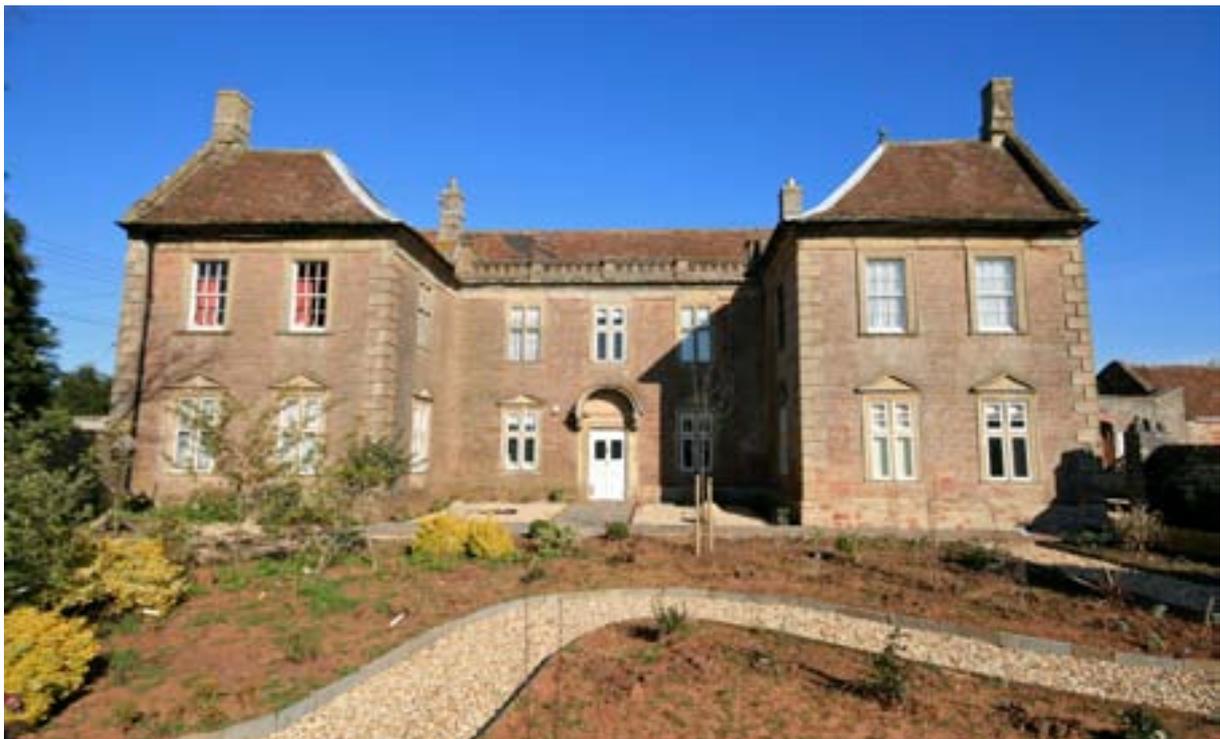
The front Baroque facade representing a short lived architectural style of the late C17th to the early C18th

Built of dressed red sandstone blockwork laid to regular courses the design contains a recessed three bay entrance front, incorporating an emphasised central door entry, surmounted by an entablature of decorated freestone frieze, cornice and balustrade framed by a pair of projecting two bayed wings finished with swept eaves and bonnet roofs. Coped gable and freestone quoins define the returns of the building together with symmetrically located chimney stacks.

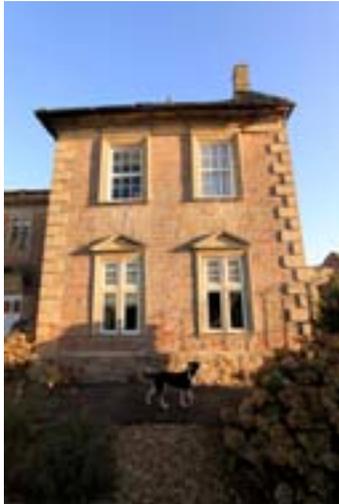
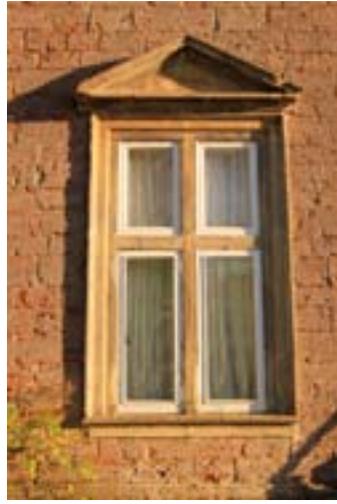
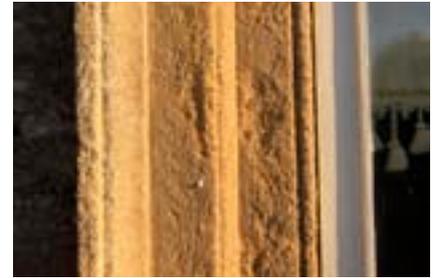
Fenestration detailing of the front facade incorporating the purer classical Palladian cyma mouldings

Whilst the architrave and pediment cyma mouldings are of a restrained classical form pertaining to the Palladian era in contrast the entry is framed by bolection moulded door jambs with a large flamboyant hood above supported by ornate console brackets containing acanthus leaf detailing. This architectural tension between the flowing Baroque detail and the more disciplined and restrained Palladian influences suggests that the construction is more likely to have been undertaken in the later period of the Baroque period around 1715.

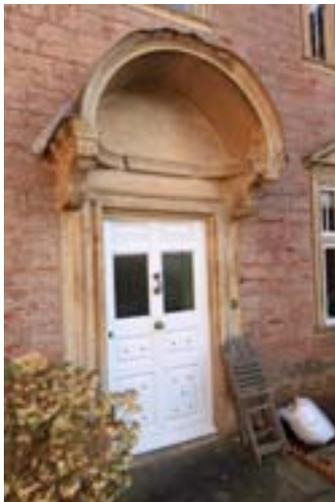
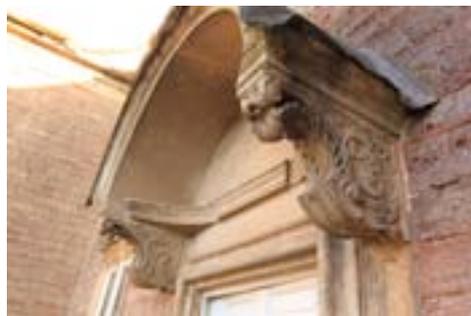
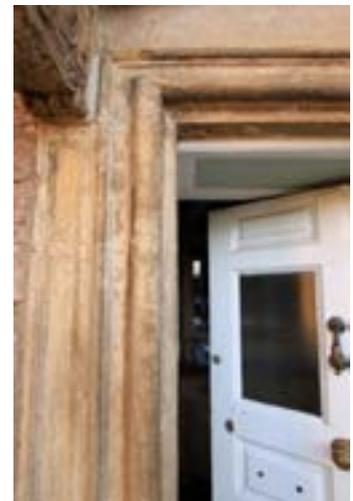
In contrast the the hood canopy, decorative consoles and bulbous bolection mouldings are traditionally Baroque

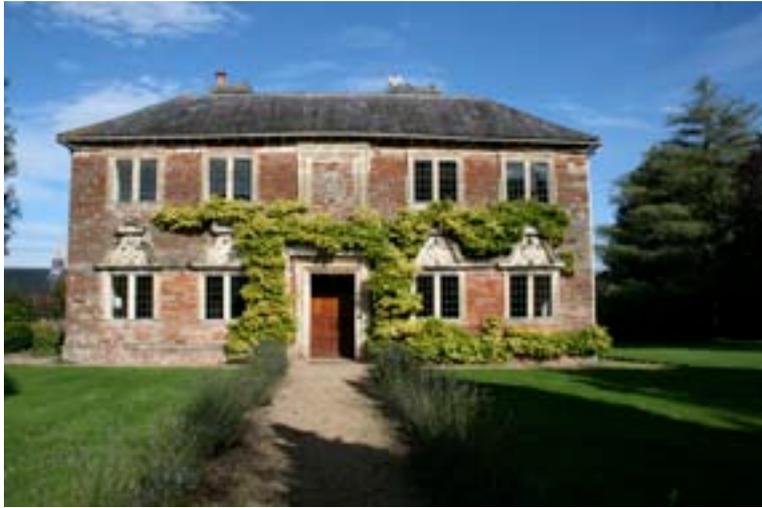
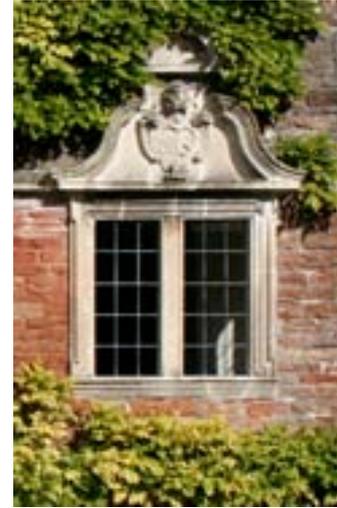
A very early example of the emerging Baroque style from the third quarter of the C17th, is to be found at Tilley Manor in the nearby parish of West Harptree. Here the window design is of a looser more florid and flowing style incorporating such detailing as broken pediments in contrast to more classically restrained pediment detailing found at the Old Parsonage.

Tilley Manor, West Harptree an example of the emerging Baroque style from the mid C17th

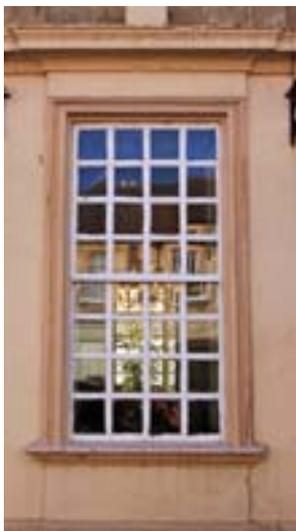
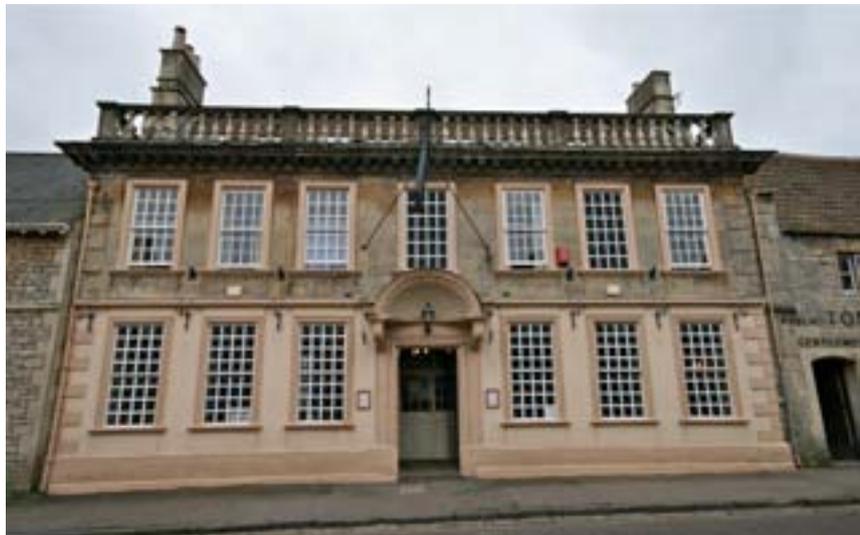
Although the detailing of the window surrounds at the Old Parsonage is considered to be the height of refinement of the day it is interesting to note that the cross transom mullion arrangement was retained in preference to double hung multi pane sashes which was rapidly becoming the fashion, as seen at the Catherine Wheel public house in Marshfield where they are set within bolection moulded architrave surrounds. The second floor sash windows that do appear at the Old Parsonage represent subsequent alteration to the original fabric undertaken in c1820.

The Catherine Wheel, Marshfield c1725 with early sash windows framed in bolection moulded surrounds

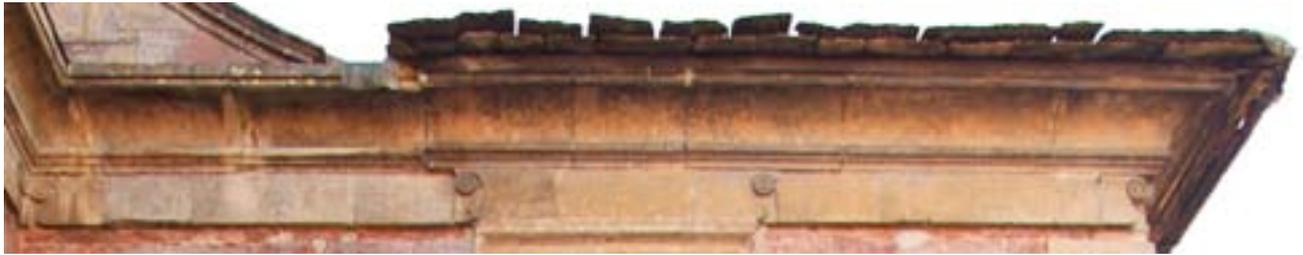
At roof level the eaves detailing at the Old Parsonage is of particular interest emphasising the Baroque characteristics of the composition through the adoption of the scroll motif and the bold undercut covered cornice.

Detail of freestone cornice detailing with ornate scroll decoration and residual stone slating above

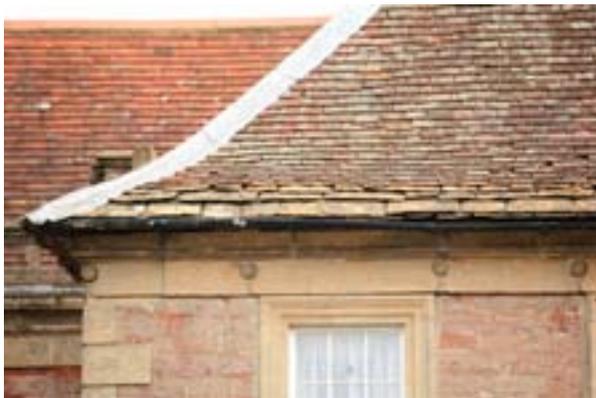
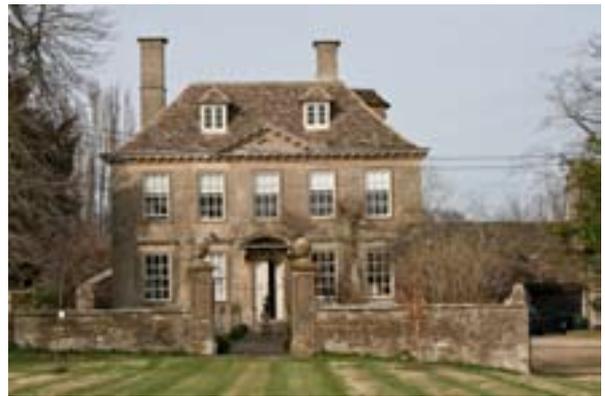
The swept eaves, bonnet style roofing at the Old Parsonage and the highly stylised comparison at Gifford Hall

This detailing in combination with the swept bonnets roofs of the projecting wings and the use of the ball finial decoration are particularly pleasing to the eye and represent typical detailing of the late C17th and early C18th. Although the existing plain clay tile roof covering compliments the composition it is a substitution for original Pennant stone slates of which three courses remain in situ at eaves level.

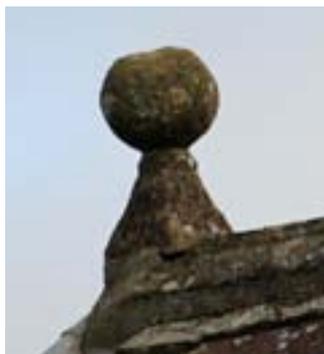
The ball finial to the roof apex

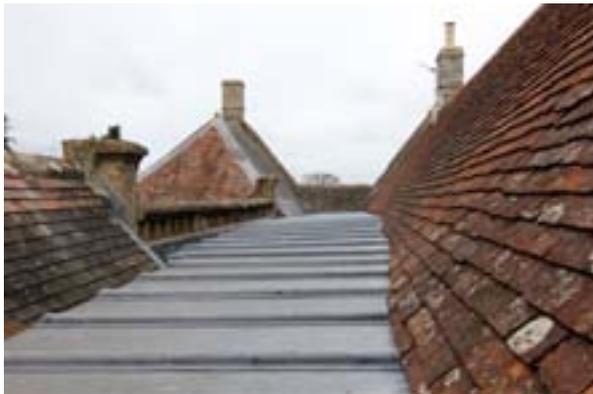
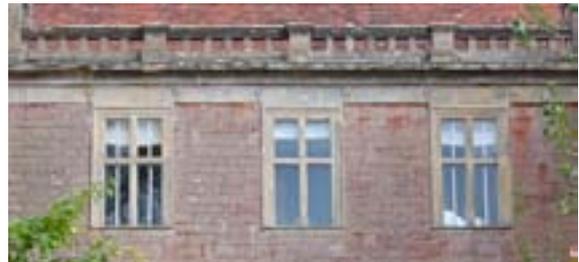
Much work and alteration at the roof level is indicative of the battle occupants have been continually faced with in keeping the elements at bay for generations. The current owners have undertaken extensive repairs to the roof including the upgrading of the flat roof area, to the immediate rear of the balustrading, replacing the inappropriate bitumen and felt covering with a traditional lead finish at enormous expense.

The replacement lead flat roof and detailing of balustrade parapet

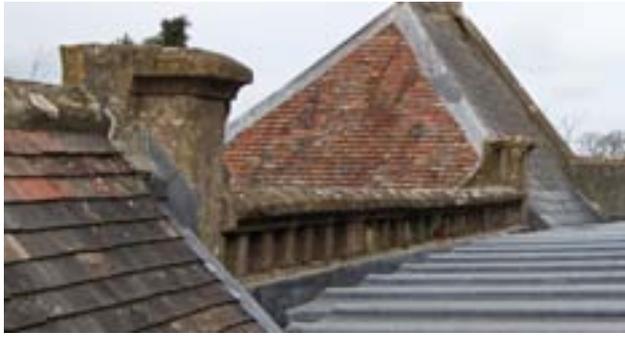
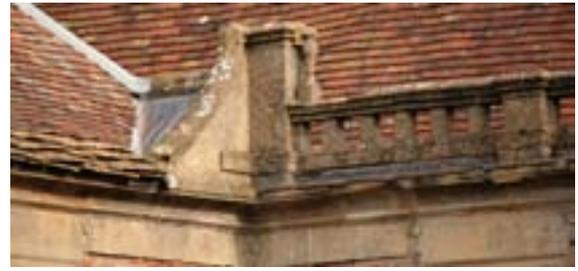
Earlier unsympathetic historic alterations have led to the 're-working' of the balustrade parapet. The reduction in height through the replacement of the original balusters with shortened, square section replacements has compromised the arrangement, however the reuse of the original moulded top rail goes some way to alleviating the impact.

The balustrading historically remodelled and reduced in height with earlier surviving work in proximity

Two original turned balusters survive remounted over the top rail, at the junction with the unaltered supporting end dies, which in turn run into attractively detailed curved upright ramping stone coping sections.

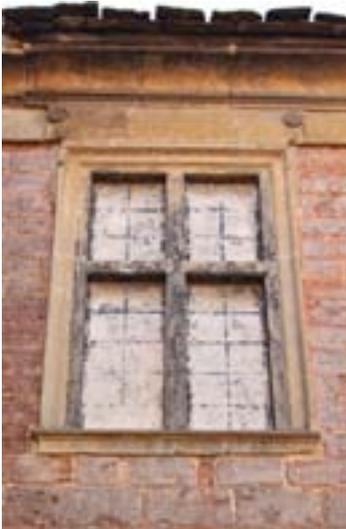
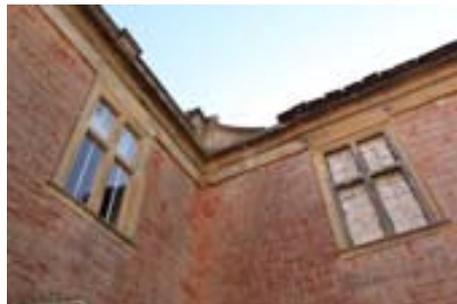
The aspiration to create a fully considered symmetrical and balanced classical composition is further reflected in the provision of blind windows to the return elevations of the projecting wings, at first floor level. This is indicative of the advanced architectural sophistication of the build with such detailing becoming an integral part of the Palladian style that was to flourish in the nearby city of Bath from the late 1720's.

Blind windows let into the facade at first floor level in the interest of balance, symmetry and proportion

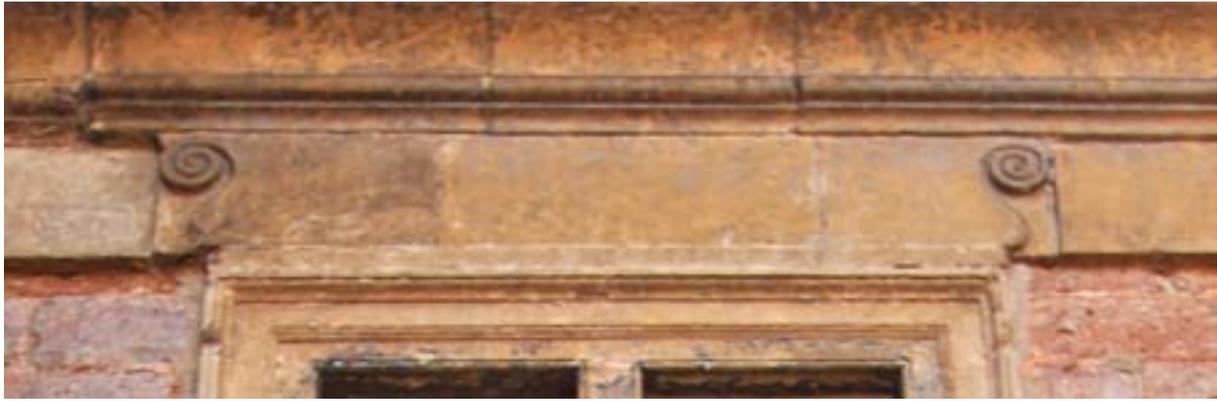
The treatment of the window head detail, held in combination with the frieze, emphasised by a shallow projection and refined scrollwork decoration, is refined in both its concept and execution and heightens the Baroque flavour of the composition.

The projecting window head decorated with Baroque style scrollwork ornament within the architectural frieze

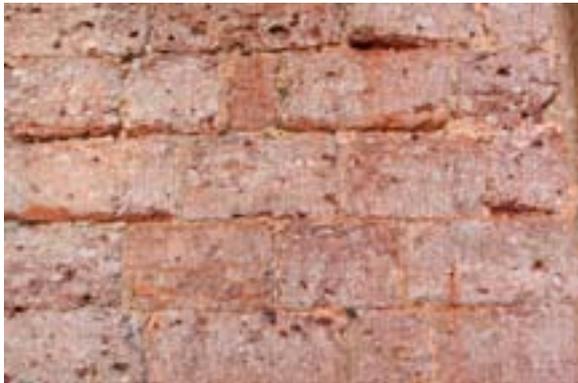
The colour of the stonework, the manner in which it has been dressed and coursed suggests that there was a desire to create an impression of brickwork which was a highly desirable building material very much in fashion at the time. Close inspection of the stonework indicates that the facade has not been rendered, except possibly at plinth level, the existence of pit marks is the result of the building being clad with ivy throughout the C19th.

Red sandstone 'brickwork' polite finish in contrast to the harling render and limewash finish of the rear elevation

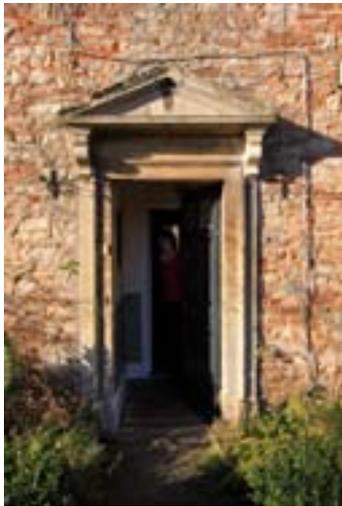
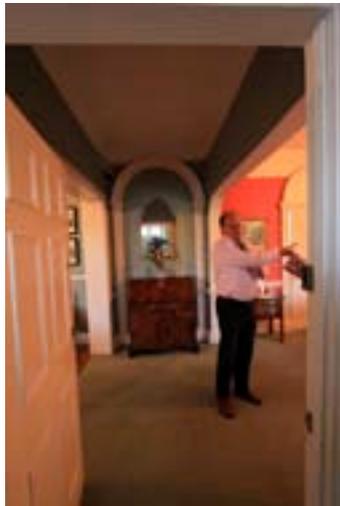
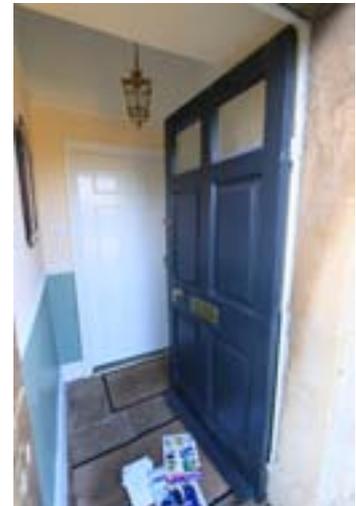
The courtyard entry leads into an altered, Pennant stone flagged, cross passage blocked up at the far end compromised by the removal of the enclosing walls and the introduction of a lobby at the entry end.

The courtyard entry leads into the original cross passage arrangement which has been successively modified

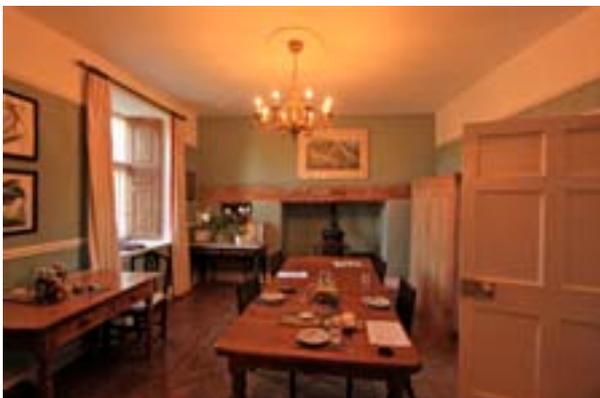
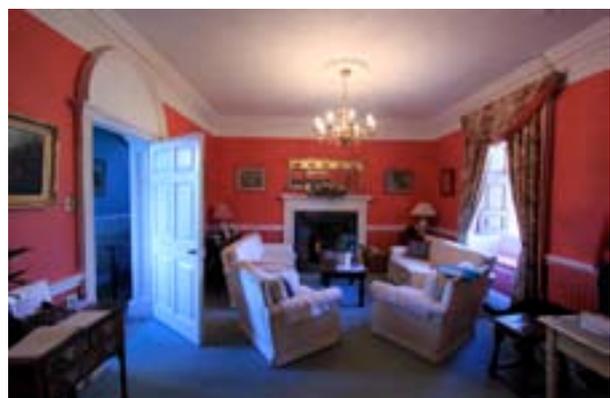
To the left, South, is located the plainer of the two rooms with a utility hearth and a flag stone floor beneath the herring bone parquet flooring finish. The current owners have undertaken significant enhancement works in this area removing modern applied finishes and infill, which had compromised the character and appearance of this part of the house, thereby introducing much enhancement.

The contrast character of the two rooms which define an older historic core to the building

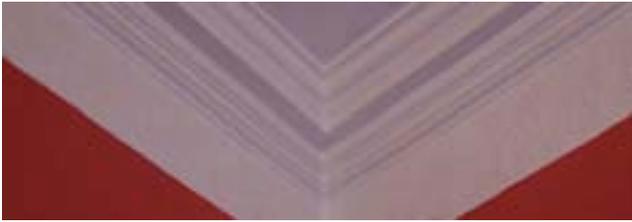
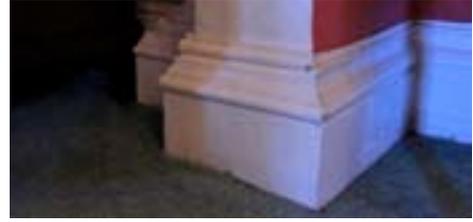
Cornice with deep corona detailing and superior skirting detail to the drawing room

To the right, North, is located the Drawing Room embellished with an early C18th style cornice as identified by the deep corona moulding, a favourite detail in the work of Wren, Vanbrugh and Hawksmoor. Works of embellishment to the door entry, leading to the lateral passageway beyond, reflects the superior architectural status of this end of the building

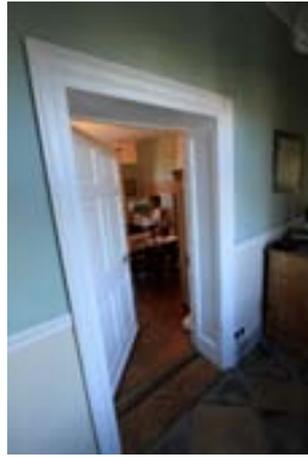
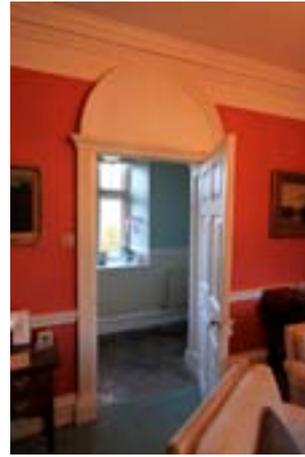
The architectural hierarchy expressed in the door surrounds

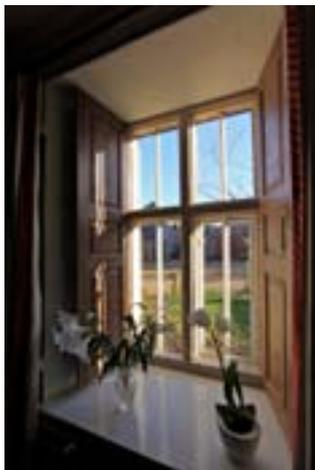
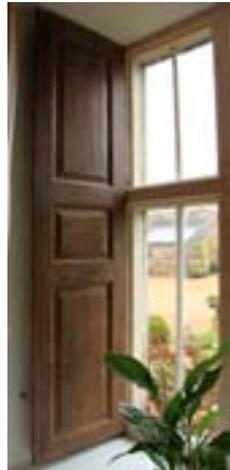
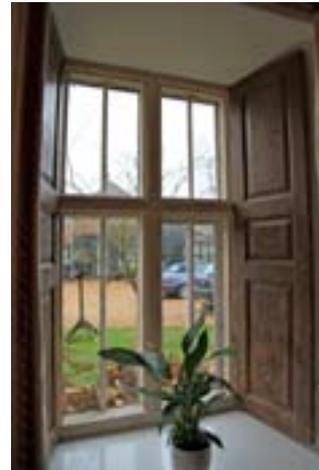
Early C18th cross transom mullioned window and shutters set in plain splayed reveal

Each room is lit by a single cross transom mullioned window set within a plain splayed reveal containing fine early C18th raised and fielded panelled shutters which are of considerable merit.

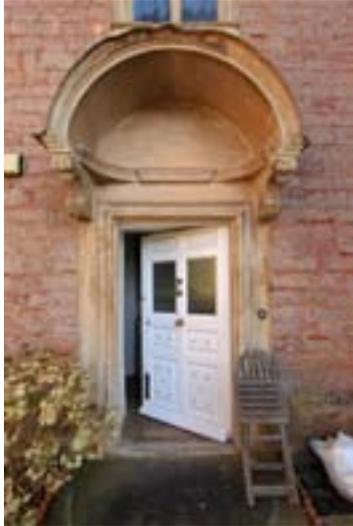
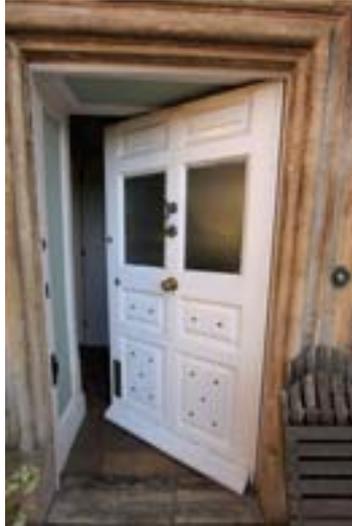
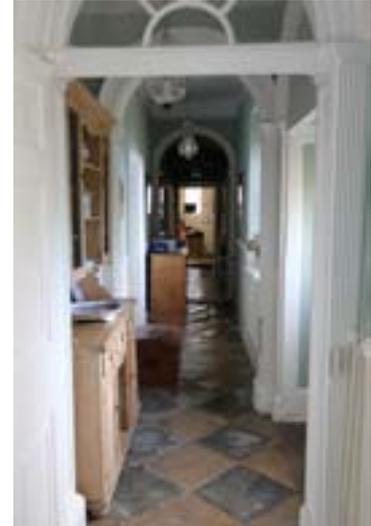
Entry through the formal polite entry of the house is protected by the large highly styled Baroque hood canopy set on highly decorated console brackets. Framed by the heavy bulbous bolection moulded door jambs the way leads through the original early C18th, eight panelled, door directly into a lobby entry incorporating a lateral passageway floored with alternate oolite limestone and Pennant flagstones laid to a diamond pattern.

The polite Baroque detailed entry leads directly into a laterally orientated ornate stone flagged passageway

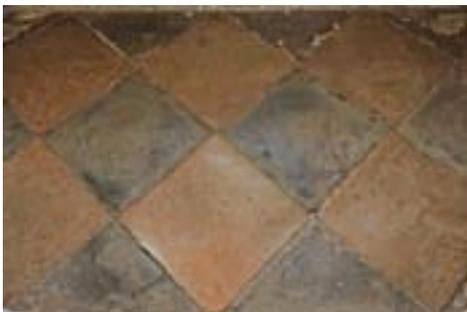
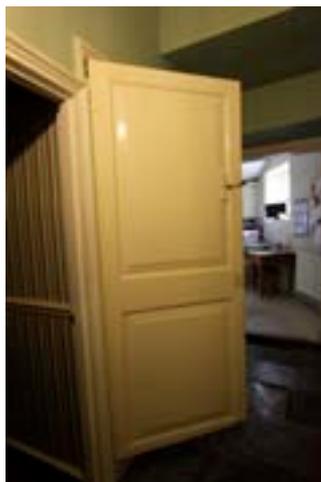
To the right, South, a tight newel service staircase enclosed by a fine example of an increasingly rare two panelled early C18th door designed detailed with a low heavy locking rail in the manner of the evolving classical fashion of the day.

Detail of the passageway flooring and newel service stair enclosure

It is interesting to note that the social significance of this arrangement is emphasised by the creation of a threshold in the stone flags, where they change from a diamond style layout to a more standardised square set pattern, denoting the contrast between the polite and service functions of the building.

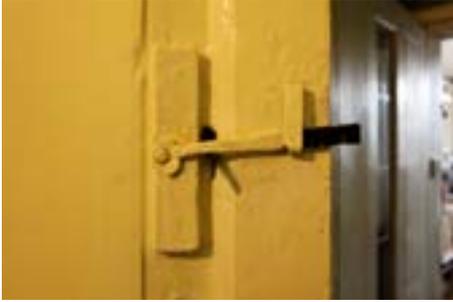
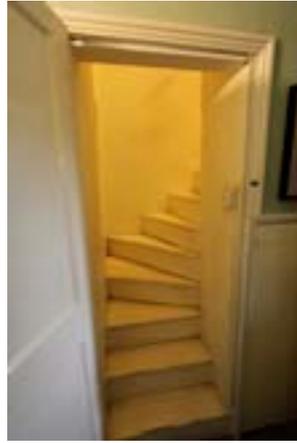
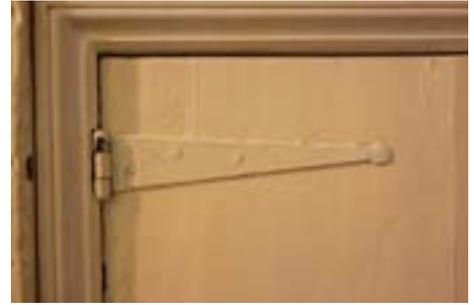
Historic latches and hinges at the base of the newel service staircase

The survival of historic latches and hinge fixtures adds to the perception of the historic space and is further testament to the sensitive approach to the historic fabric adopted by the current owners who appreciate the retention of such detailing and the contribution they make in defining the character and appearance of the building.

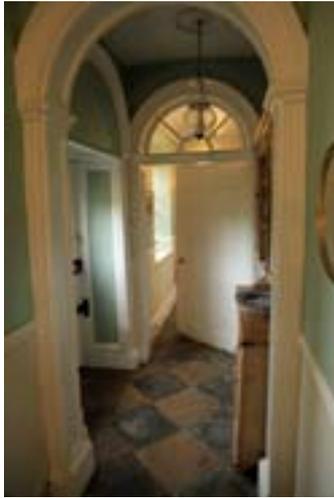
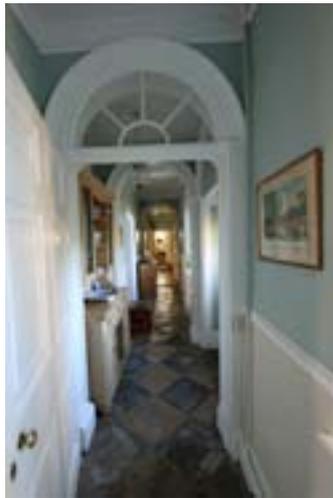
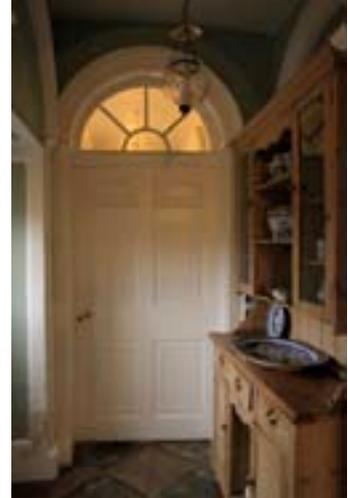
The lateral passageway is punctuated by a series of half round architraved openings incorporating a medley of juxtaposed stylised fluted pilasters surmounted by refined impostes supporting moulded segmental arched openings above.

The lateral passageway punctuated by a series of half round arched openings mounted on fluted pilasters

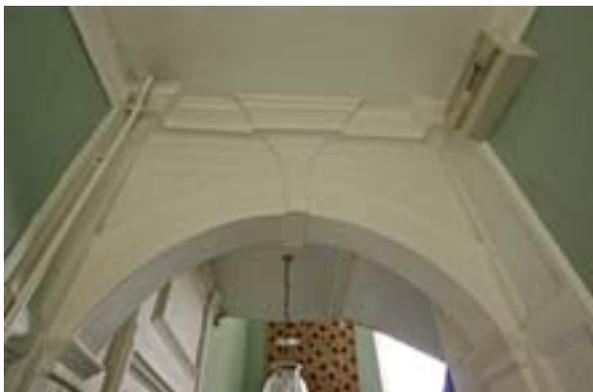
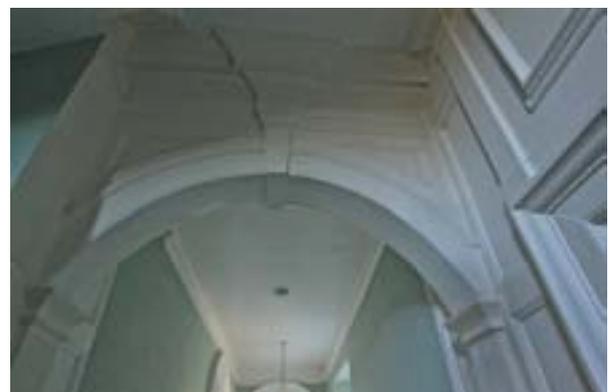
An internal Regency fanlight and door of c1820 origin has been introduced to further improve living conditions and provide additional privacy to the upper more architecturally refined part of the house. Beyond the original early C18th panelled head, containing a dropped keystone, a hallmark of the Baroque style, defines the threshold entry into this upper part of the house reserved for people of consequence.

The drop keystone panel detailing announcing entry into the upper part of the house with the contrasting return face

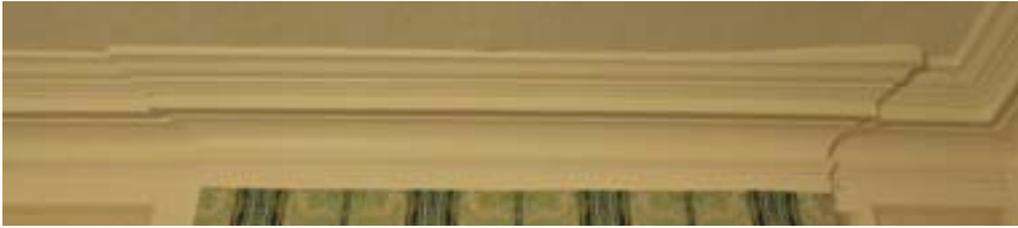
Projection of entablature to emphasise window opening

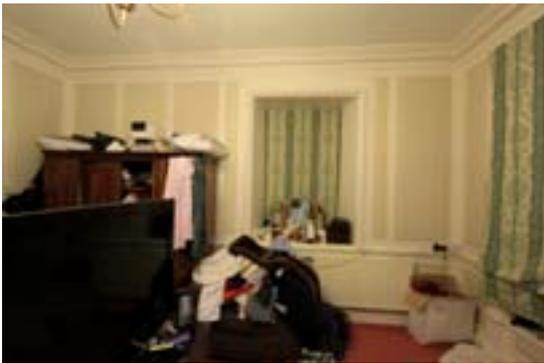
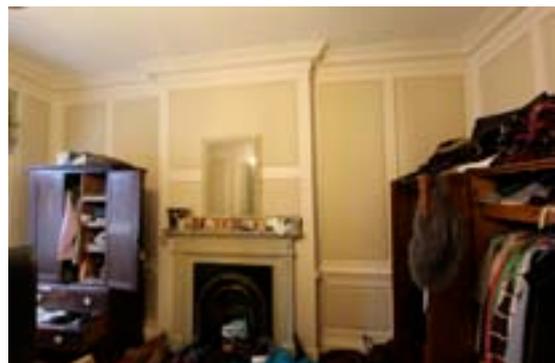
Raised and fielded panelling with bolection mould architraves to door and window openings

The detailing includes raised and fielded panelling incorporating a low heavily moulded dado rail with the door and principal window opening, to the return wall, framed by bolection moulded surrounds and projections contained within the entablature, in the typical early C18th Baroque manner.

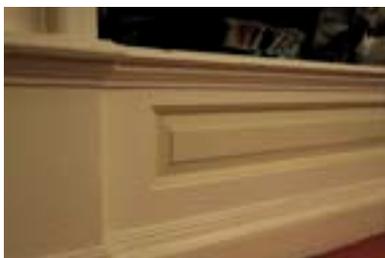
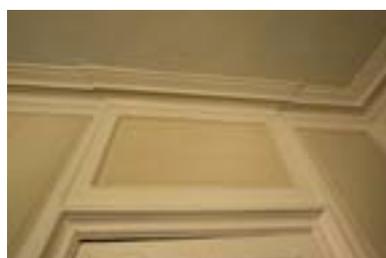
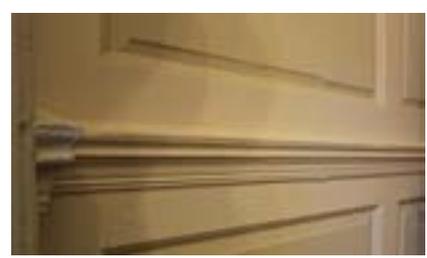
Architectural elements within the panelling which are representative of the early C18th

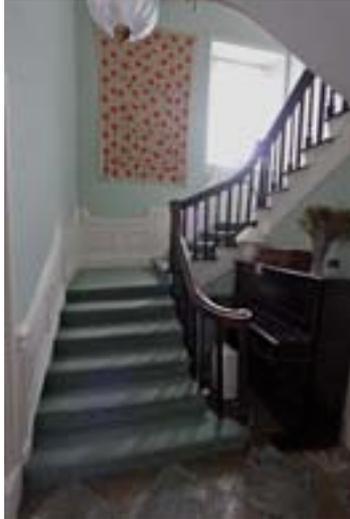
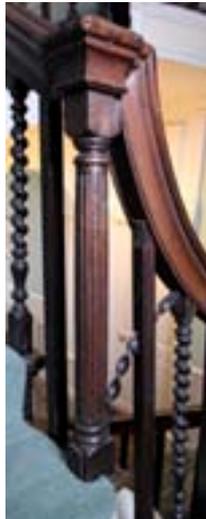
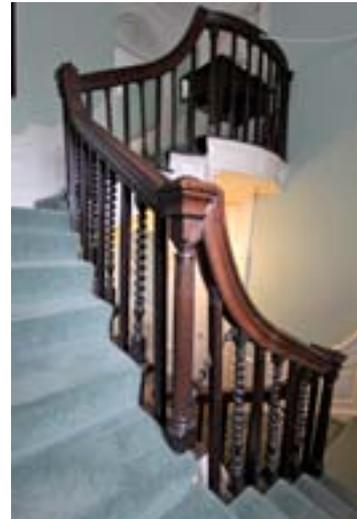
The principal stair of the house is located adjacent to the panelled parlour within the extended bay beyond the earlier build. It is a very fine example of an early classically detailed timber staircase, in the Baroque style, incorporating fluted newel posts and alternate barley twist balusters surmounted by a broad heavily moulded handrail.

The principal staircase of the house incorporating classical detailing in the high Baroque style

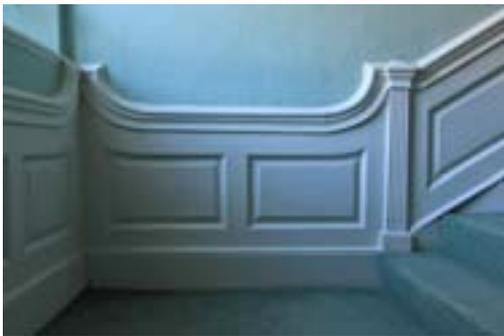
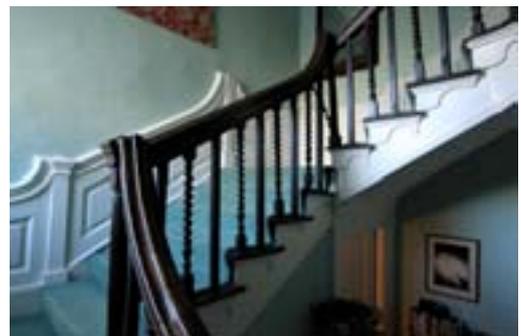
Dado panelling to the wall face mirroring the detailing of the handrail and integral newel posts

Progression up the staircase is enhanced by the provision of a panelled dado to the wall, mirroring the ramping of the handrail and the position of the newel posts, the latter expressed by the use of half engaged fluted pilasters incorporating a capital and plinth detail to match.

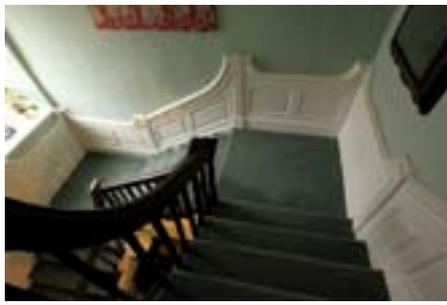
The extent of the dado panelling

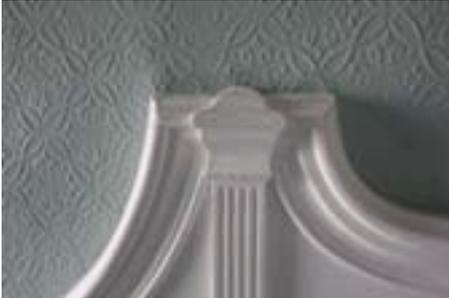
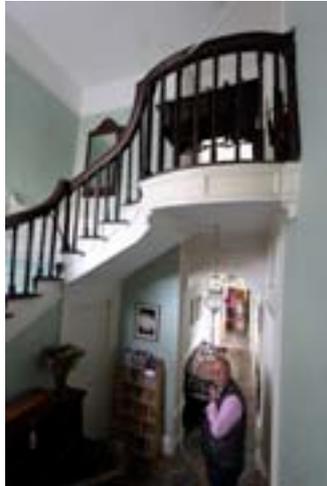
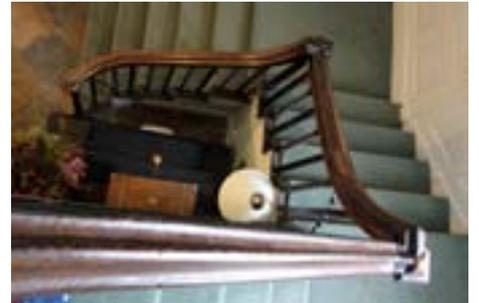
Classical detailing present within the early C18th high Baroque staircase

Set out on a dog leg quarter landing plan arrangement the broad shallow timber treads add to the sophistication of the composition. The sense of progression to the upper floor of the house is further enhanced at its summit by the introduction of a bow front cantilevered projection embellished with reduced florid style pendants in harmony with the exuberant scroll moulding decoration to the return of the treads.

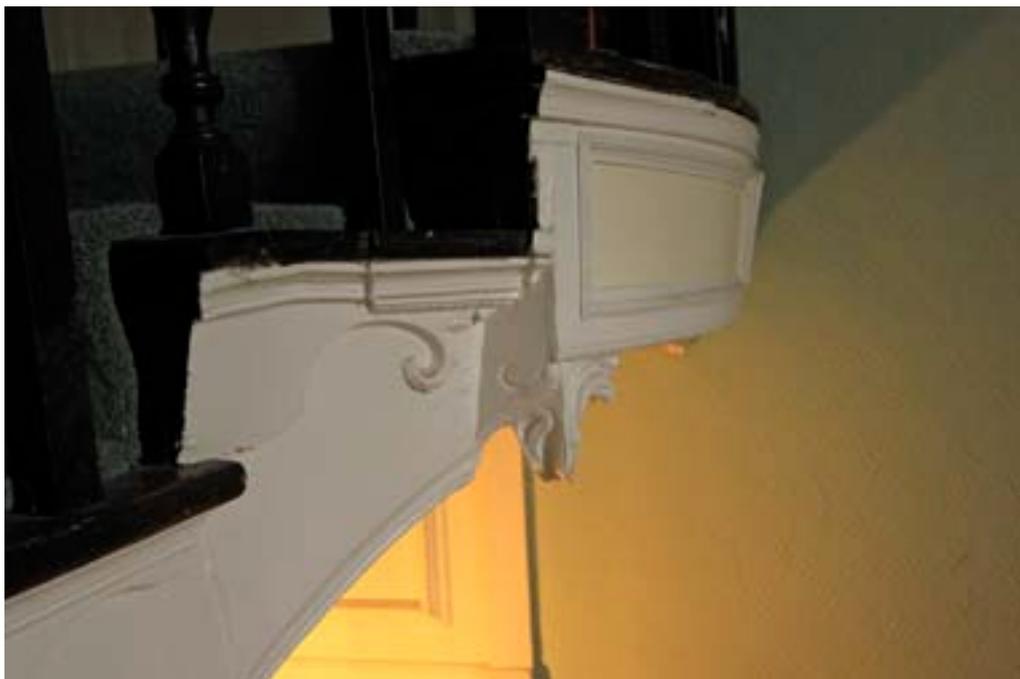
The cantilevered landing incorporating bowed panels and reduced decorous pendants

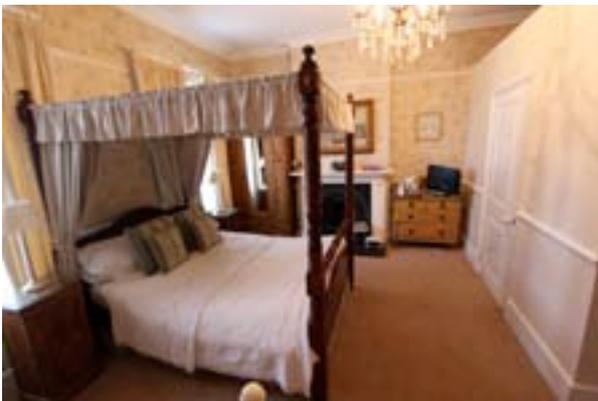
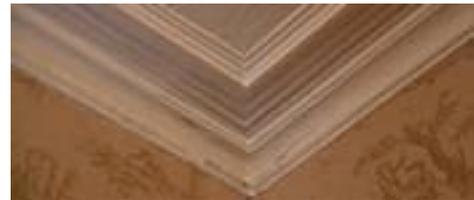
A program of work is proposed to improve the design of the en suite bathroom and repair of the cornice

It is therefore proposed to undertake a scheme of works within this room which includes the remodelling of the existing en suite bathroom, the repair of the damaged areas of the cornice and the removal of the inappropriate picture rail moulding all in the interest of enhancing the character and appearance of this lesser room within the building.

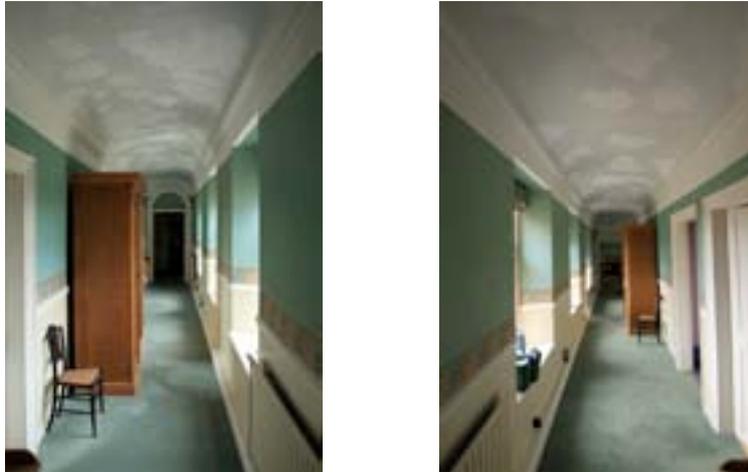
The corridor landing at first floor level

A lateral corridor landing, running the length of the building, provides access to the first floor rooms and is located directly over the ground floor passageway beneath (see appendix one existing first floor plan). Containing a barrel vaulted ceiling, visually supported by long linear projecting mouldings, the corridor is highlighted at each end by introduction of architraved openings, left open at the staircase case end and fitted with a door at the service end.

Something of the feeling of the long gallery pertains to this space allowing for the display of paintings and the provision of indoor entertainment on inclement days. The elevated perspective is heightened by a series of three cross transom mullion windows set in deep low reveals encouraging one to take in the long view from the house.

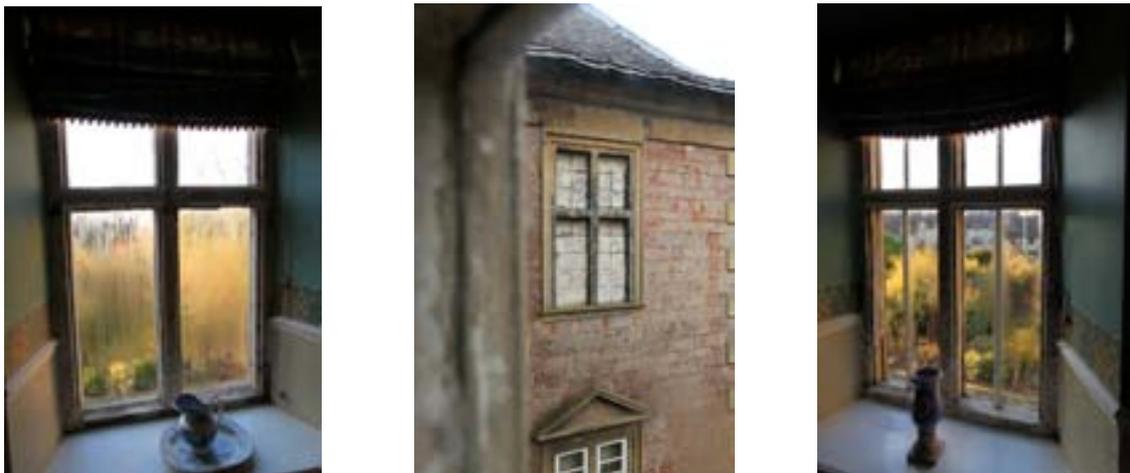
Detailing of corridor windows and evidence of high condensation levels within the building

The square quarry light fenestration pattern was lost during an early C20th refurbishment, however the original pattern is reflected in trompe l'oeil to the blind window and confirmed in late C19th photographs. It is noted that the fixed glazing exasperates condensation levels and demonstrates how the raising of funding is so necessary for the future benefit of the building in resolving such issues.

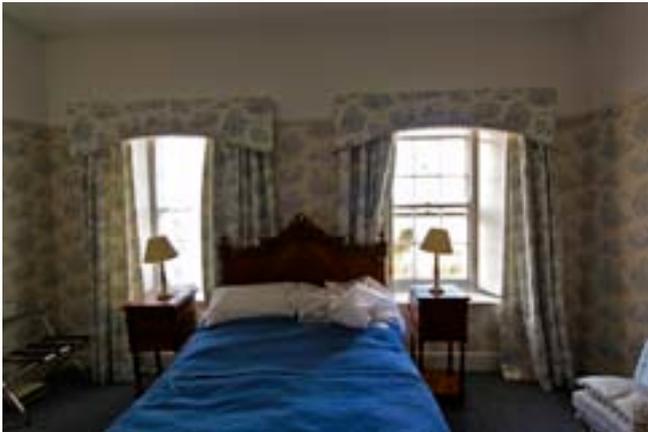
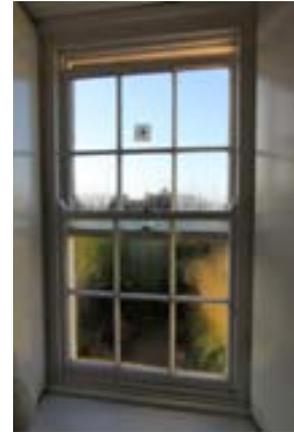
The replacement sash windows in the balancing ante room to the South projecting wing

The balancing ante room in the South projecting wing is also relatively plain in its detailing. It has been subject to much change and upgrading, in an effort to keep the elements at bay and retain the room in constant use which is essential for the care, maintenance and conservation of the historic fabric.

Double hung sash windows have been introduced into plain unadorned reveals, replacing the original cross transom stone mullions and associated timber casements. An en suite bathroom has been introduced, prior to 1993, in order to resolve the issue of limited bathroom provision, decorated out in a manner to minimise the visual impact.
