THE OLD PARSONAGE

AN ANALYSIS OF THE ARCHITECTURAL AND HISTORIC SIGNIFICANCE

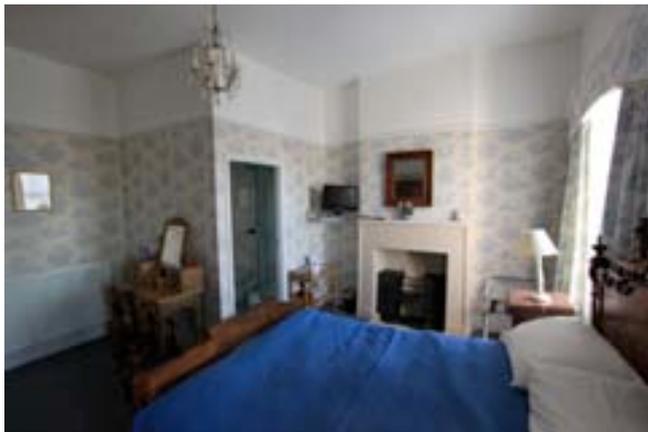
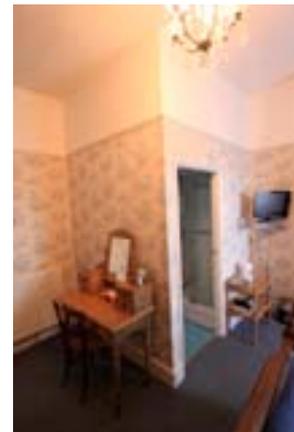
An en suite bathroom has been introduced, prior to 1993, to address the limited provision

Double hung sash windows have been introduced into plain unadorned reveals, replacing the original cross transom stone mullions and associated timber casements. An en suite bathroom has been introduced, prior to 1993, in order to resolve the issue of limited bathroom provision, decorated out in a manner to minimise the visual impact.

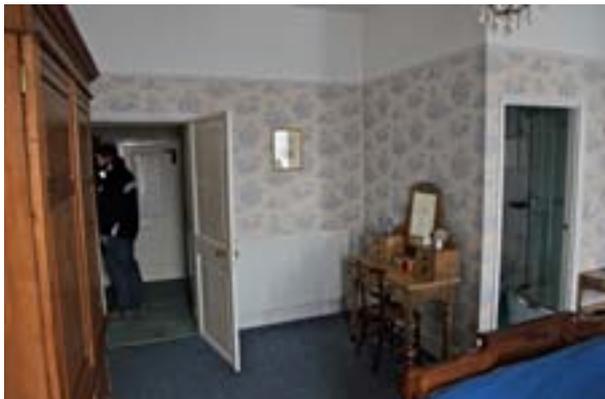
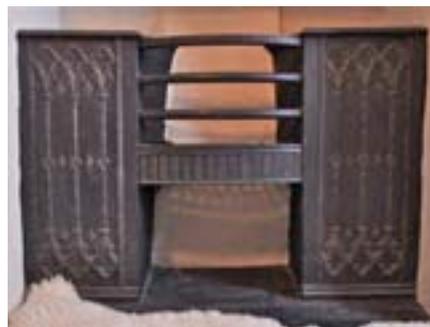
Detailing within the South projecting wing incorporating a Regency Gothick hob grate

Although the room is entirely devoid of any cornice detail it does contain a further example of an original two panelled early C18th door as well a fine example a Gothick hob grate dating from c1820 set within an open stone surround.

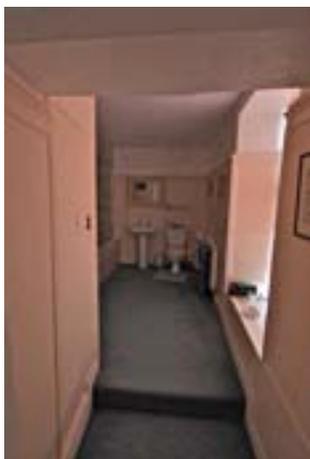
The cutting through of the original chimney stack and view into the stable-yard

This enclosed room could only be made accessible through the cutting back of the original chimney stack. The provision of such a closet/cabinet arrangement was becoming increasingly fashionable from the later C17th, its roots lying in the open medieval hall and the later Elizabethan country house as a place of withdrawal.

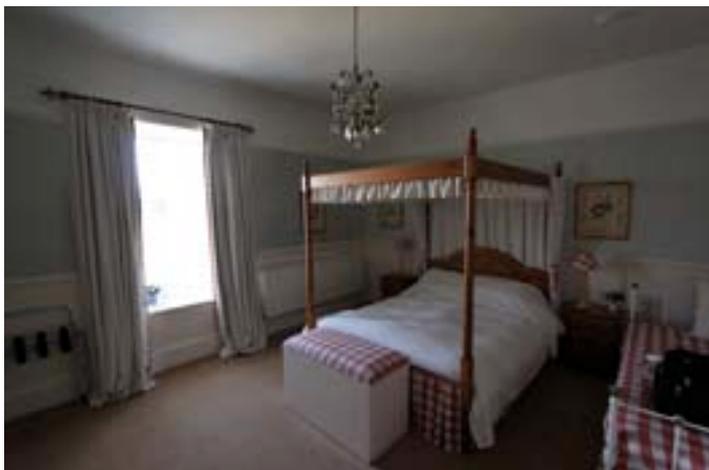
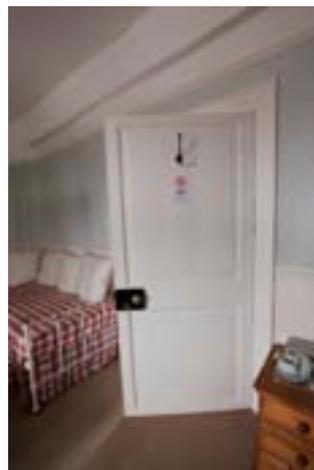
The current bedroom layout and historic alterations within the lateral wall

A substantial timber beam has been inserted at soffit level and the area of walling beneath reduced in depth. Positioned directly below the junction of the wall plate and the flat roof it is most likely that this represents repairs undertaken following the weathering of this weak point within the structure of the building between the flat and pitched roofs.

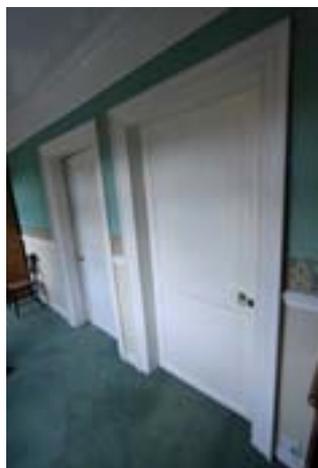
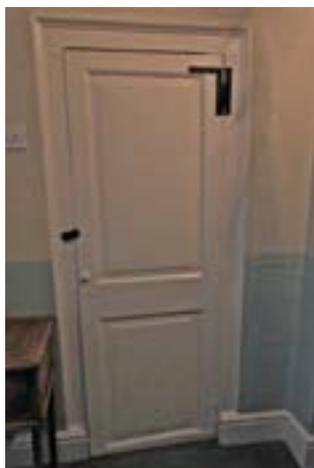
A series of fine early C18th doors and associated early C18th ironwork hinges in the corridor landing

A diminutive two panelled linen cupboard set into the chimney breast return, incorporating early 'L' shaped hinges, at the North end of the corridor defines the extent of the build prior to the early C18th.

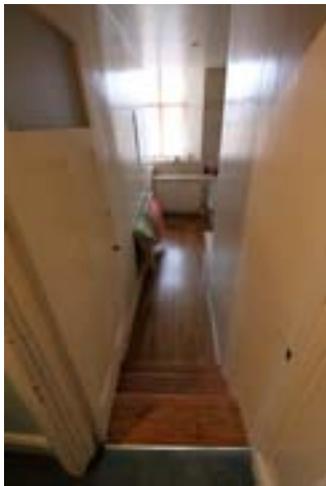
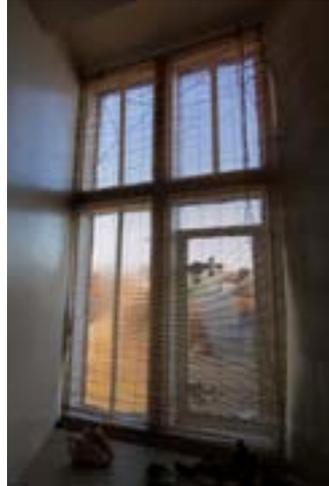
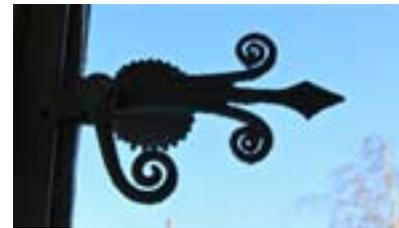
The original external gable walling has been cut back to accommodate an inserted window

An additional bay to the South contains a narrow ante room which has been historically converted into a family bathroom with the rising service staircase beyond. The external gable wall of the earlier house has been cut back to allow the introduction of a cross transom mullion window in a symmetrical and balanced position within the external facade, all in the interest of architectural purity. A further indication of the refinement and attention to architectural detailing to be found in the early C18th build is provided by the decorous ironwork casement window latches which have survived.

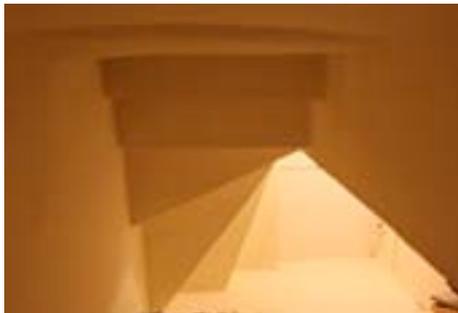
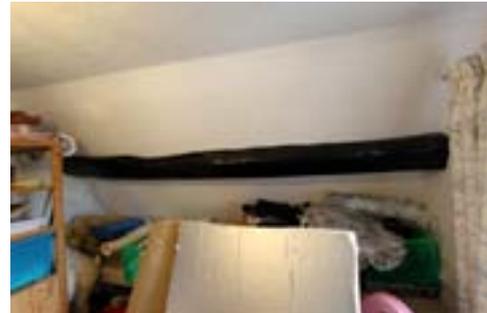
The newel stair and extended roof bay

Newel stair leads up into the extended bay within the roof space which has been historically upgraded. The main body of the roof beyond is of an 'A' frame double purlin construction much of which has been replaced with modern timber, however historic rafters and purlins are in evidence in the separate roofs of the two projecting wings.

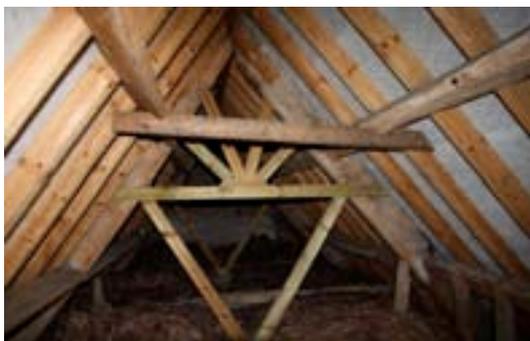
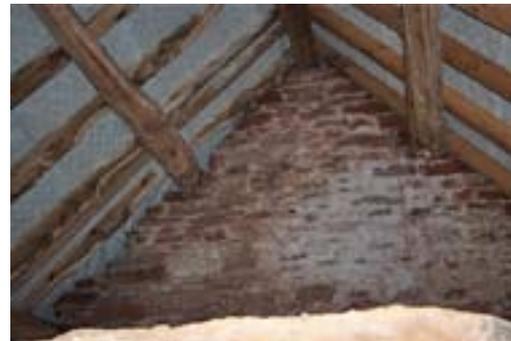
Contrasting replacement and historic timbers in evidence in the roofing pattern
